## Olmaha ... Major Hull Restoration Projects

Caretaking of a classic wooden boat to keep it healthy is a constant task. Olmaha has had electrical system updating, mechanical maintenance, annual bottom painting, periodic hull and brightwork re-finishing, as well as caulking, refastening and occasional new planking. In addition she has also presented some larger shipwright challenges for "big timber" items. Here is a little photo essay of three of these.

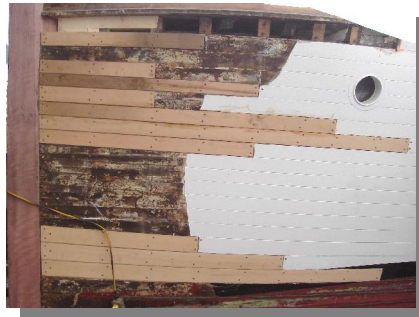
Chris went straight to the 11' x 12" x 8" gumwood stem to diagnose a serious hidden defect that had eluded several thorough surveyors over the preceding years. Under the nice paint and cladding, as well as on close inspection in the chain locker, the stem had appeared to all to be flawless.

Then Chris set his gaze and paint scrapper upon it. In some extremely violent collision in the dim past the stem had in fact been fractured at the rabbet from top to bottom. Out of sight behind bow cladding, over subsequent decades, rainwater had tracked down the crack to cause deterioration of the plank ends and fasteners. Up on the ways, after the cladding was removed, with little effort the stem virtually fell out leaving the bow wide open. Clearly, a fairly gentle bump on the stem from a minor collision with a deadhead or a dock would likely have produced a

catastrophic result.

Some bad planks were removed or bad ends cut back to healthy wood and, to preserve as much original structure as possible, a new deeper stem was skilfully crafted from purpleheart.

With no "dry-fit" opportunity the new stem was rolled out and driven down between the plank ends to mate perfectly with the keel, leaving perfect caulking space. A work of art!

A new breast hook was constructed and the bow further restored with new fastenings and a substantial amount of new Douglas fir planking.

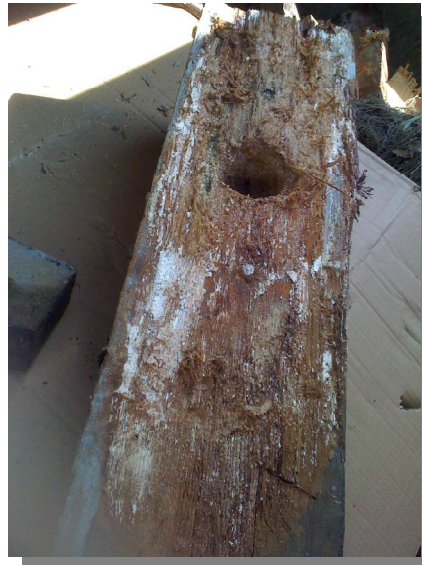
With a critical eye and suspicion the hull tumblehome in the aft starboard quarter seemed to have slightly lost its smooth curve. As an immediate consequence of her stem splitting collision Olmaha had likely slewed about striking her starboard quarter. Inspection behind the inner hull revealed 8 consecutive cracked frames and

of wood hydrolysis in the horn timber around the rudderpost and keel bolts.

Inspection of the horn timber revealed that not only had it been attacked by hydrolysis, but also, although invisible from external inspection, it had also been extensively fractured, undoubtedly due to a rudder grounding in the distant past.

This clearly could only be properly corrected by completely replacing the horn timber, a major surgical challenge, but not beyond the skills of Chris Earl. After hauling Olmaha stern-first up the ways, the rudder, shaft and garboard planks were removed.

The aft 15 feet of the hull was shored up on each side and the water tanks in the transom rolled out of the way.

The transom knee was removed, the floor timbers cut away and the horn timber extracted piecemeal leaving the top of the keel bolts

protruding out of the deadwood.

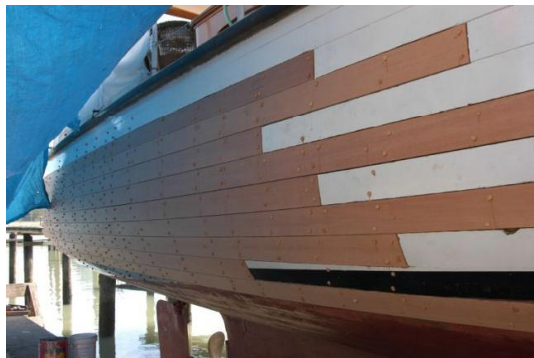
associated deteriorated planks. Look at all the lovely new planking!

Steam bent oak was used to sister 18 ribs and yellow cedar cheek pieces, notched to accept the old floor timbers, were added along the horn timber. New cedar floor timbers were then installed and the garboard planks replaced
