CONDITION AND VALUATION SURVEY FOR THE VESSEL:

'HONEY BEA'

1972 GRAND BANKS 32

VESSEL SURVEYED: 'HONEY BEA' – 1972 GRAND BANKS 32' / FILE NUMBER: 2222023016

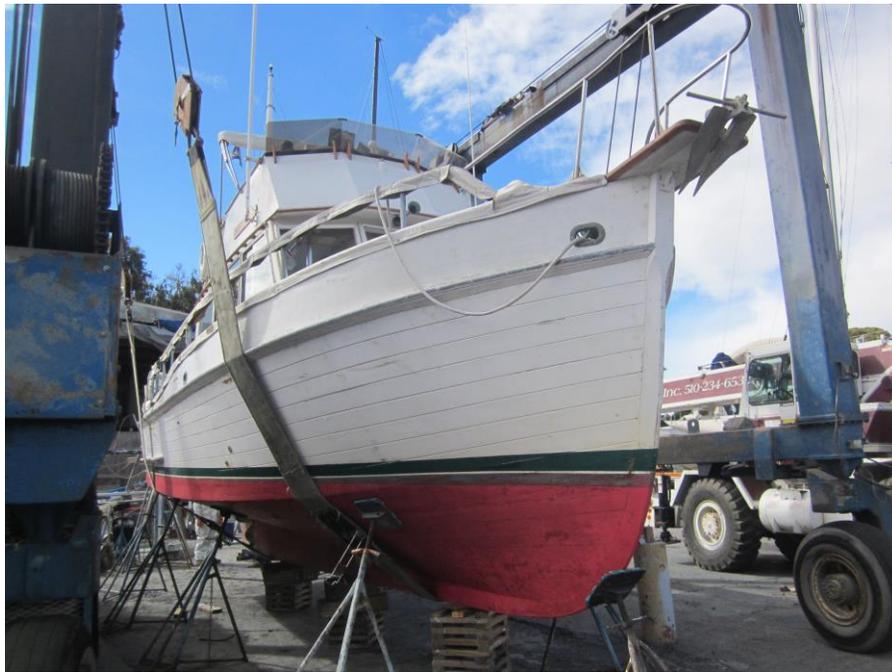
At survey site: Berkeley Marina; starboard forward view.

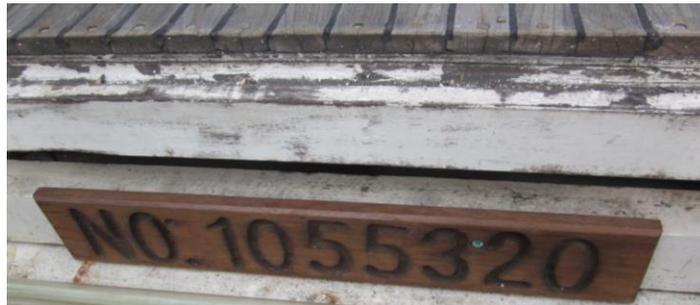
Vessel's documentation number fixed in aft cockpit hold.

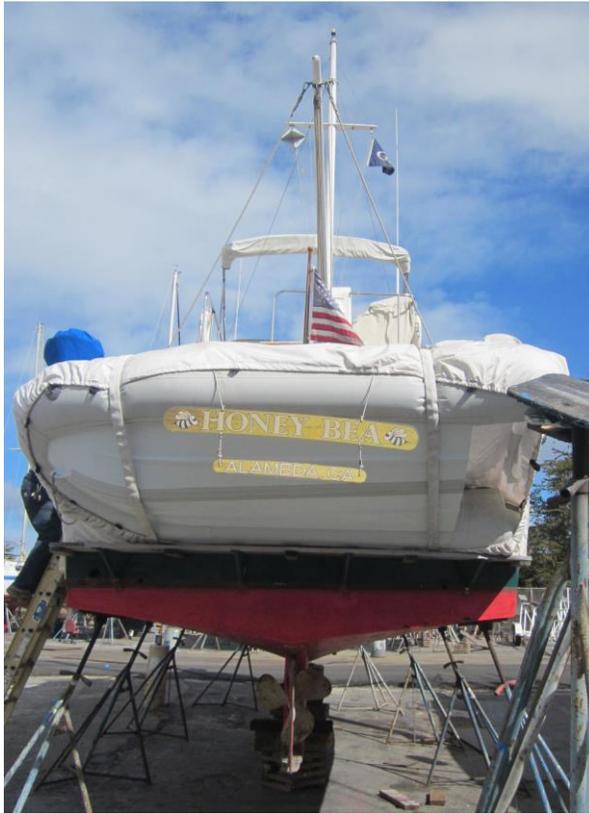
Transom view with tender.

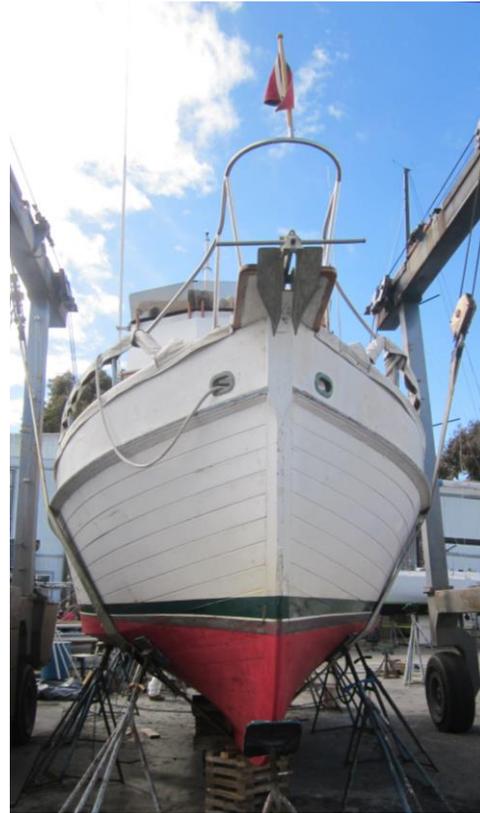
Bow and stem view.

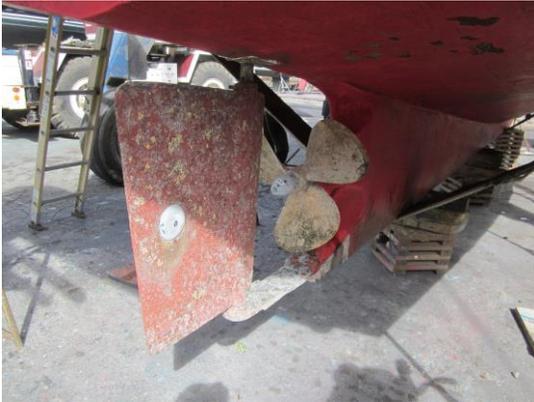
PROPELLERS – Three-bladed bronze, 24" diameter, LHD. Good condition – renewed in 2020.

Rudder: 20"x27" bronze.

Rudder and prop.

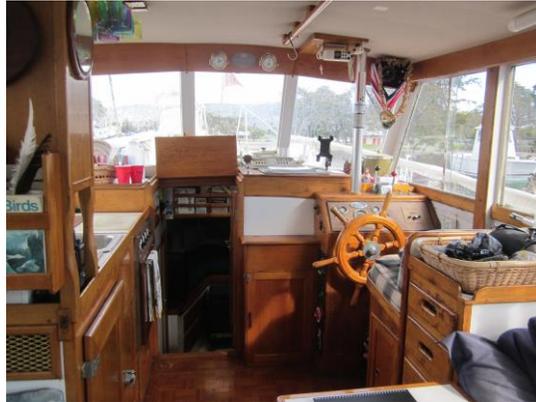
Lower helm station starboard of galley.

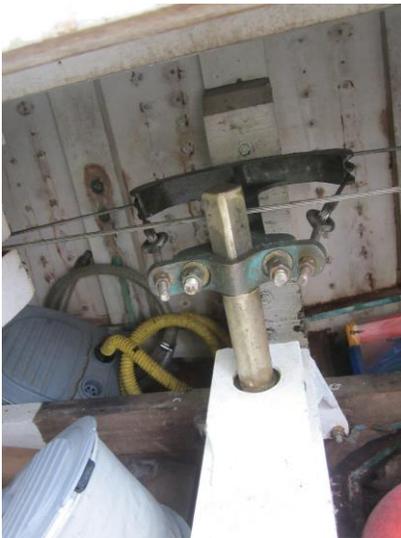
Number of Stations: Two - pilot house and flybridge, starboard. Cables renewed for both helms two years ago.

Upper rudder steering quadrant and cables.

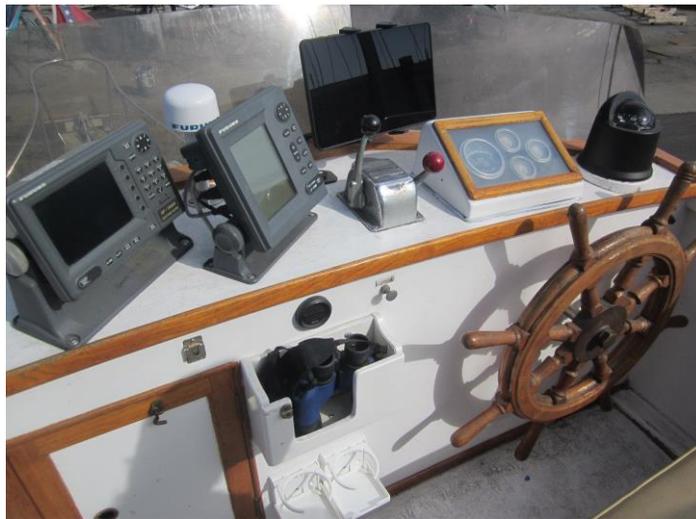
Upper helm station.

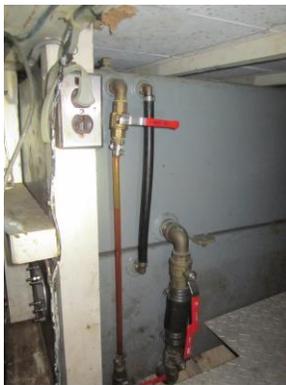
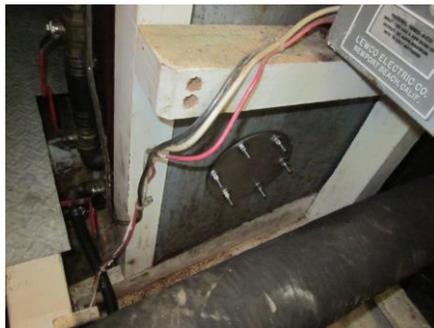
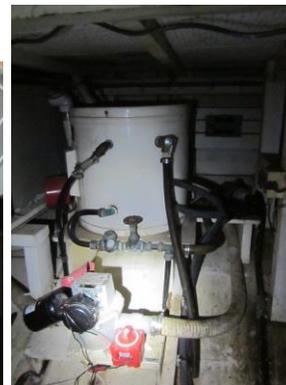
Starboard and port fuel tanks: sight gauges, shut off valves, inspection plate; water heater and battery switch.

1. Maintain the ship's log of all maintenance, renewals, upgrades etc.
2. The water stains in main salon, below the window are old. Monitor the wood closely for dry rot – there is some darkening of the wood in the head and above the water heater. Address these before it gets worse.

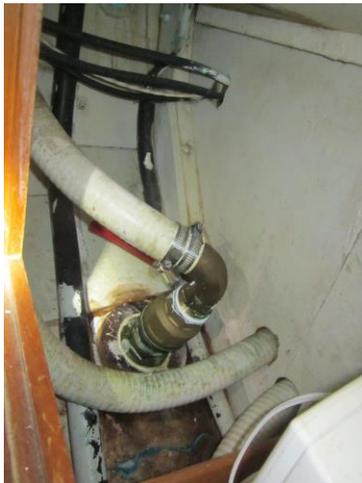
Head discharge valve.

*****Most waters in San Francisco Bay and the Delta require that MSD type III heads have to be locked or the discharge valves wire-tied in off position to ensure there is no overboard discharging of untreated black water within 3 miles of the coastline.***

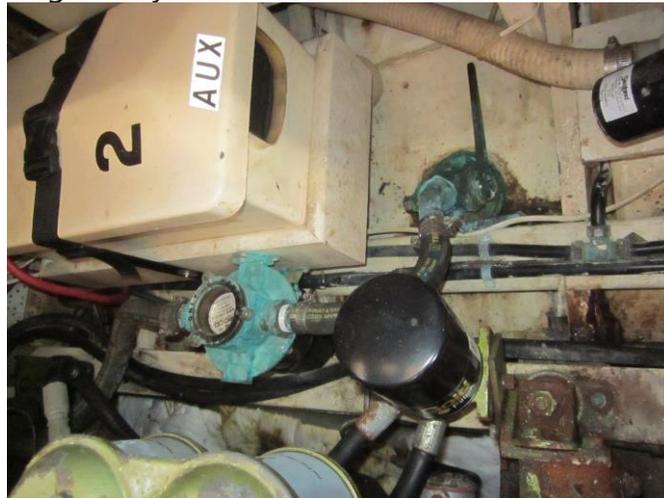
THRU-HULL FUNCTION	TYPE	CONDITION
1) Engine water intake, starboard of engine.	Bronze ball valve with screened exterior.	*Some corrosion.
2) Head intake, forward cabin bilge, starboard.	Bronze ball valve.	New.
3) Head discharge, under head sink.	Bronze ball valve with 2" thru-hull exterior.	Good. Thru-hull new.
4) Transducer.	Starboard, engine bay.	New.
5) Wash down pump	Bronze ball valve with screened exterior port engine bay.	Good.

Engine intake valve and strainer and starboard battery box.

1. Corrosion found was minimal for a salt-water vessel and Mr. Smith has been cleaning it off fairly well. The bronze hull fittings and thru-hulls valves have some corrosion and should be cleaned off, investigated for extent and then the affected structure treated with an appropriate corrosion inhibitors. The fittings at the transom have the most corrosion.
2. ABYC recommends that a fixed fire system be installed in an enclosed engine room; that all fire extinguishers be serviced annually by a qualified fire technician, and that a smoke or fire alarm is installed in vessels with galleys.
3. Ensure CO and smoke alarm are operational whenever people are aboard.

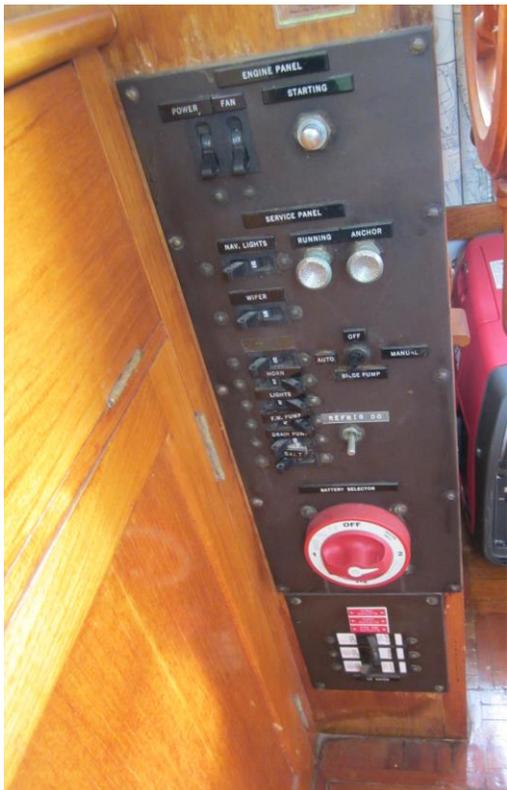
DC and AC main panel at lower helm console;

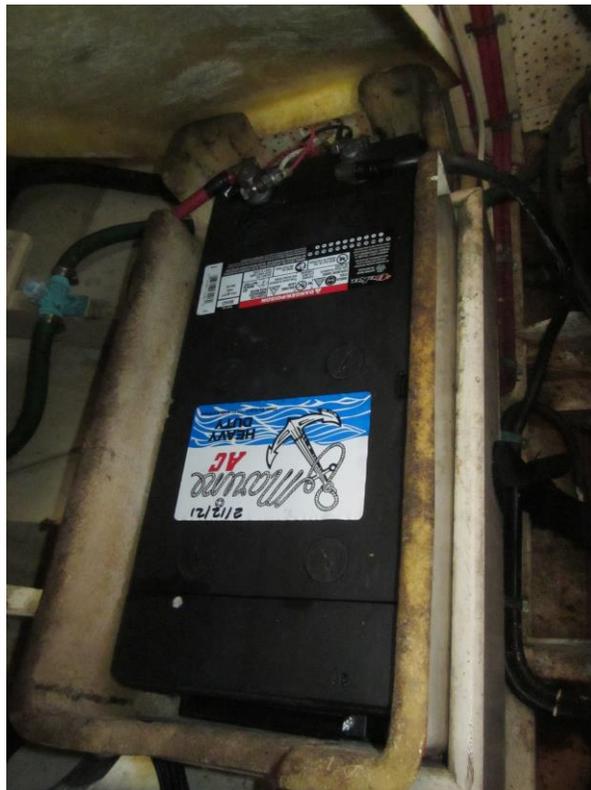
Condition: New – dated 2/12/21. Terminals clean.

port battery in FRP vented box with cover removed.

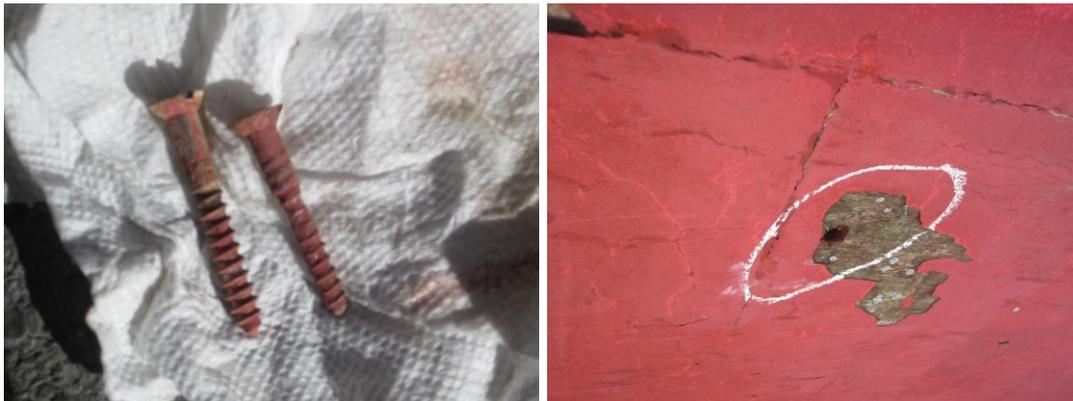
EXTRA PICTURES OF PULLED FASTENERS

Exterior Color & Condition: Red bottom, blue boot stripe, and white top sides. Bottom to be sanded and repainted while hauled out. No soft wood found on wet hull. Random fasteners were pulled from the four quadrants of the wet hull surface and all were found in good condition.

Silicon bronze screws pulled from port and starboard by the butt joint show minimal corrosion with threads still sharp. The bungs were flush to the planks and wood was in good condition.
