Zachary W. Simonson-Bond, NAMS-CMS
Kingspoke Marine Surveying
PO Box 4 • Clinton, Washington • (360) 202-2125
kingspokemarine@gmail.com

File Number: 27024023

M/V *Sandavore*

Inspection for Insurance Purposes ▾

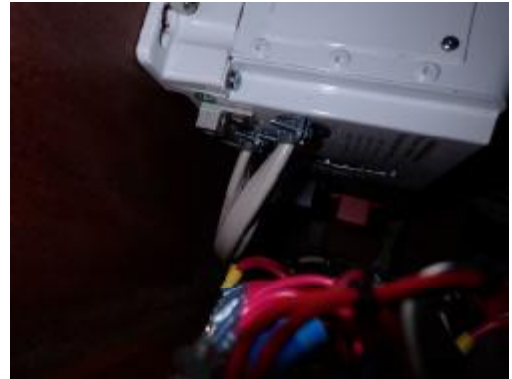
- 3.) Charger/inverter lacks a chassis grounding wire. ABYC Standard A-31 states that a DC grounding conductor shall be connected between the chassis and the engine negative terminal or its bus. The size of the conductor shall be the same size as the DC positive conductor or one size smaller.

Recommend Install chassis grounding conductor according to ABYC recommendations.

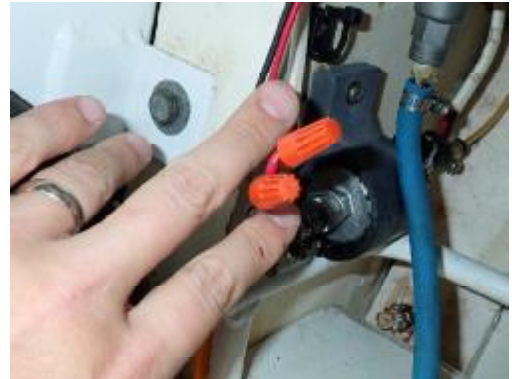
- 4.) Wire nuts were sighted in various locations throughout the vessel. ABYC Standard E-11 § 14.3.6 states: "Twist on connectors (i.e., wire nuts) shall not be used."

Recommend Replace wire nuts with marine-grade crimp connections. Heat shrink in potentially wet locations.

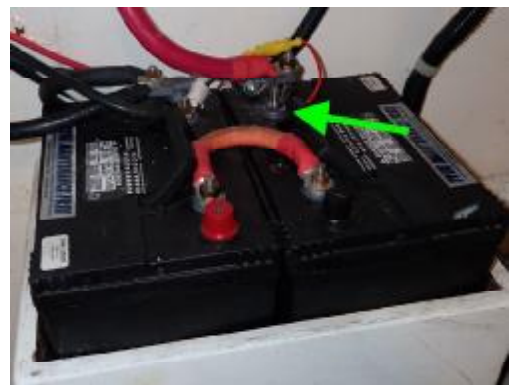
- 5.) Battery cables secured with wingnuts. ABYC E-10.8.3 states: "Battery cables and other conductors size 6 AWG (13.3 mm²) and larger shall not be connected to the battery with wing nuts."

Recommend Secure battery cables with a nut using a wrench.

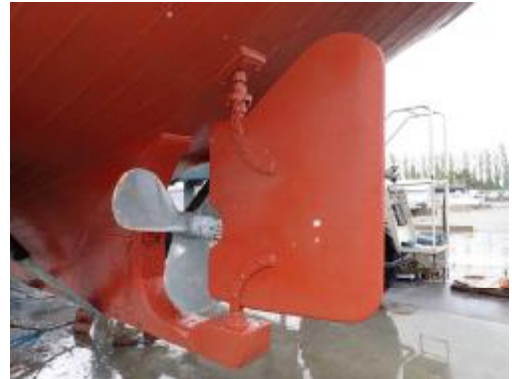
- 6.) One propeller blade was approximately 1/4" out of alignment with the other blades.

Recommend If desired, remove the propeller and have a propeller shop realign the blades.

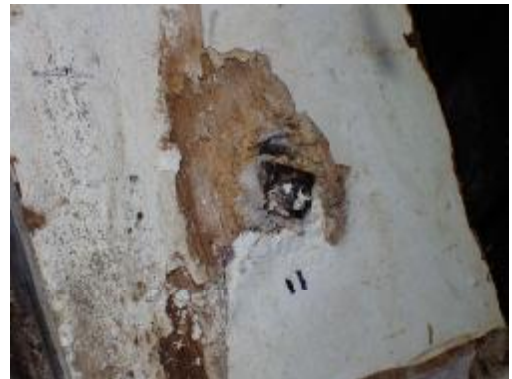
- 7.) White crystals were seen encircling a bolt on the inboard face of the stem. These are likely hydroxyl salts, an unwanted byproduct of protection by sacrificial anodes. A high concentration of hydroxyl ions can break down the lignin in the surrounding wood (delignification).

Recommend White vinegar will help to neutralize the alkaline salts and the reaction should bubble. Dilute the area after with freshwater then dry the area. This will not solve the underlying cause of the hydroxyl creation, but will slow the effects on the surrounding wood.

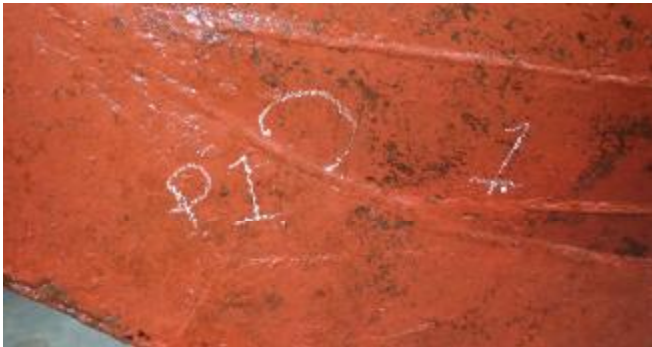
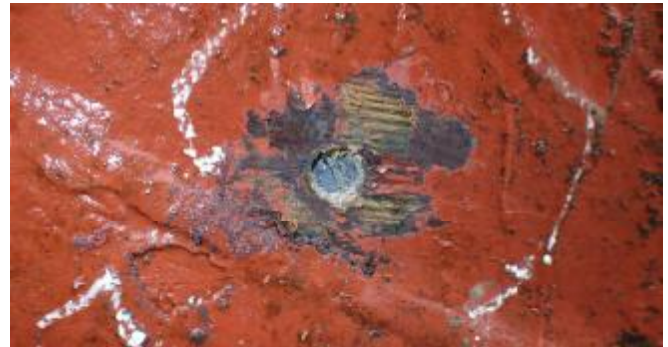
Port, 1st broad, hood-end.

Galvanized, slot-head screw. Could not remove.

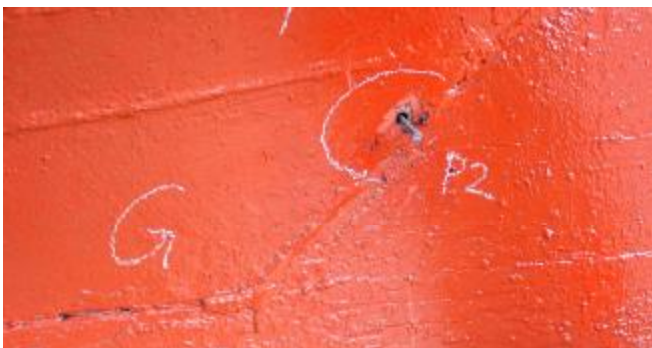
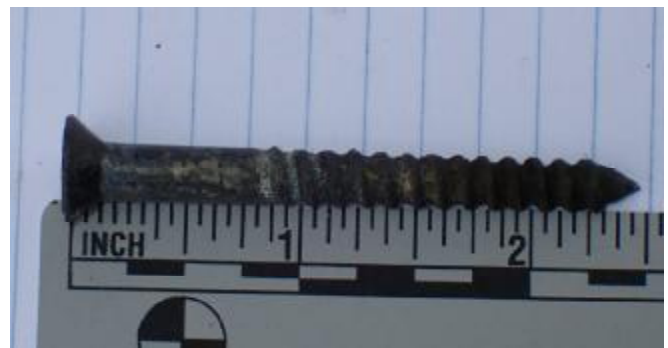
Port, garboard, aft hood-end.

Galvanized, slot-head screw, 1/4" ϕ x 2-1/2".

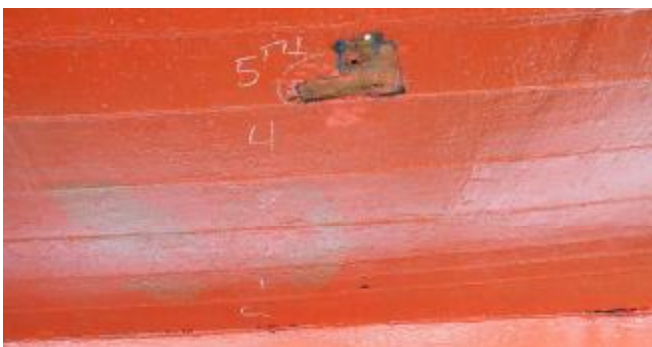
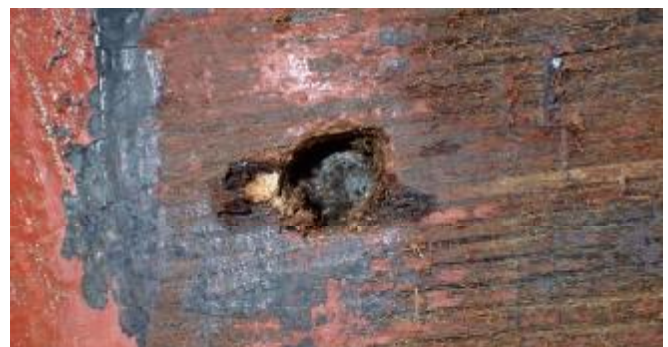
Port, 5th broad, mid hull, mid plank, below head.

Boat nail. Sounded with 4# hammer and pin punch.

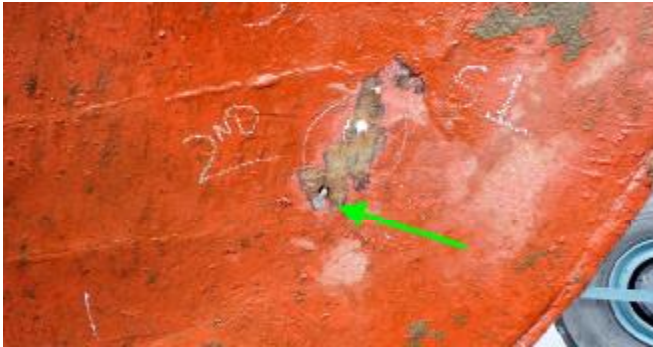
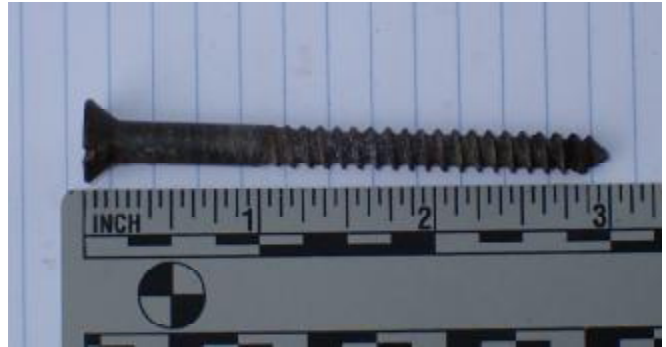
Starboard, 2nd broad, hood-end.

Galvanized, slot-head screw, 1/4"ø x 3".

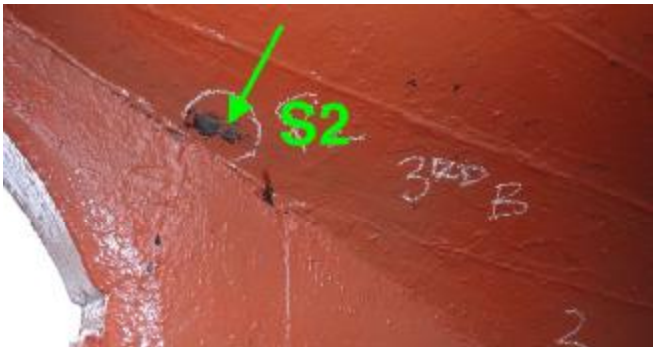
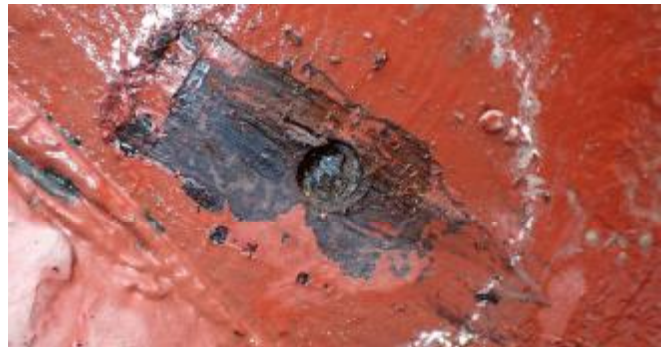
Starboard, 3rd broad, aft hood-end.

Galvanized, slot-head screw. Could not remove.
