## Olmaha ... Major Hull Restoration Projects

Caretaking of a classic wooden boat to keep it healthy is a constant task. Olmaha has had electrical system updating, mechanical maintenance, annual bottom painting, periodic hull and brightwork re-finishing, as well as caulking, refastening and occasional new planking. In addition she has also presented some larger shipwright challenges for "big timber" items. Here is a little photo essay of three of these.

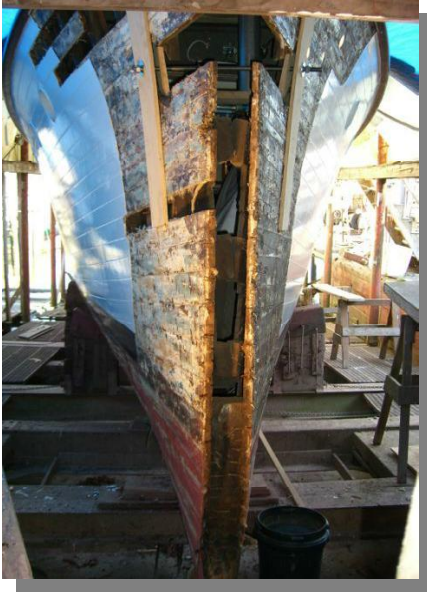
Chris went straight to the 11' x 12" x 8" gumwood stem to diagnose a serious hidden defect that had eluded several thorough surveyors over the preceding years. Under the nice paint and cladding, as well as on close inspection in the chain locker, the stem had appeared to all to be flawless.

Then Chris set his gaze and paint scrapper upon it. In some extremely violent collision in the dim past the stem had in fact been fractured at the rabbet from top to bottom. Out of sight behind bow cladding, over subsequent decades, rainwater had tracked down the crack to cause deterioration of the plank ends and fasteners. Up on the ways, after the cladding was removed, with little effort the stem virtually fell out leaving the bow wide open. Clearly, a fairly gentle bump on the stem from a minor collision with a deadhead or a dock would likely have produced a

Some bad planks were removed or bad ends cut back to healthy wood and, to preserve as much original structure as possible, a new deeper stem was skilfully crafted from purpleheart.

With no "dry-fit" opportunity the new stem was rolled out and driven down between the plank ends to mate perfectly with the keel, leaving perfect caulking space. A work of art!

A new breast hook was constructed and the bow further restored with new fastenings and a substantial amount of new Douglas fir planking.

The restored bow was nicely finished off with purpleheart cladding, a bronze anchor plate and a bronze bow iron, fabricated by cutting a bronze propeller shaft in half.
